Attachment 2

Attachment 3
Photograph Log

Photograph Log for EPA's December 3, 2010 Electrochem Solutions RCRA and CWA Inspection

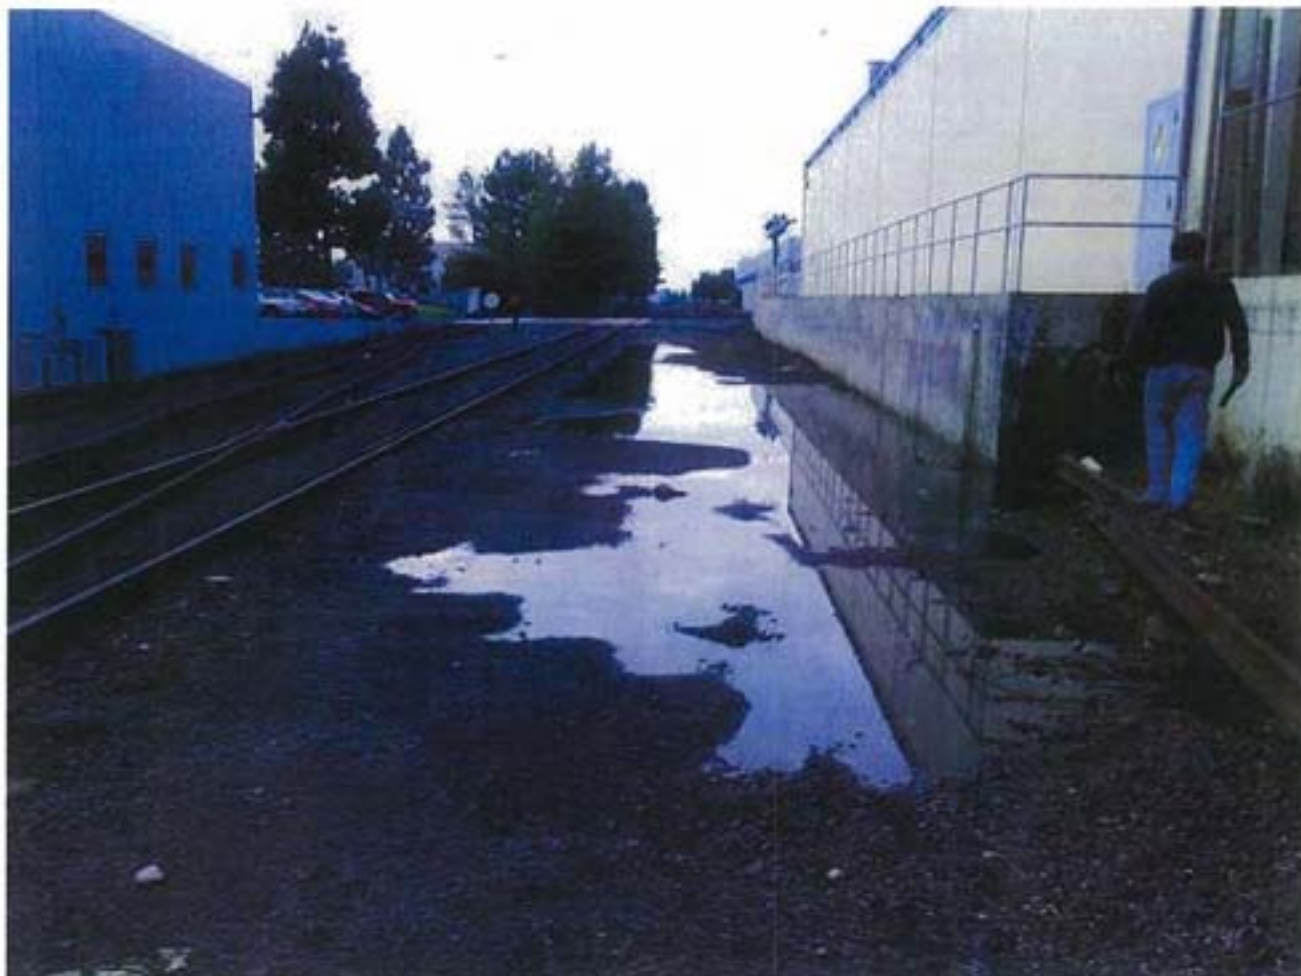
Storm water ponding due to drain cut at exit 12-9-10

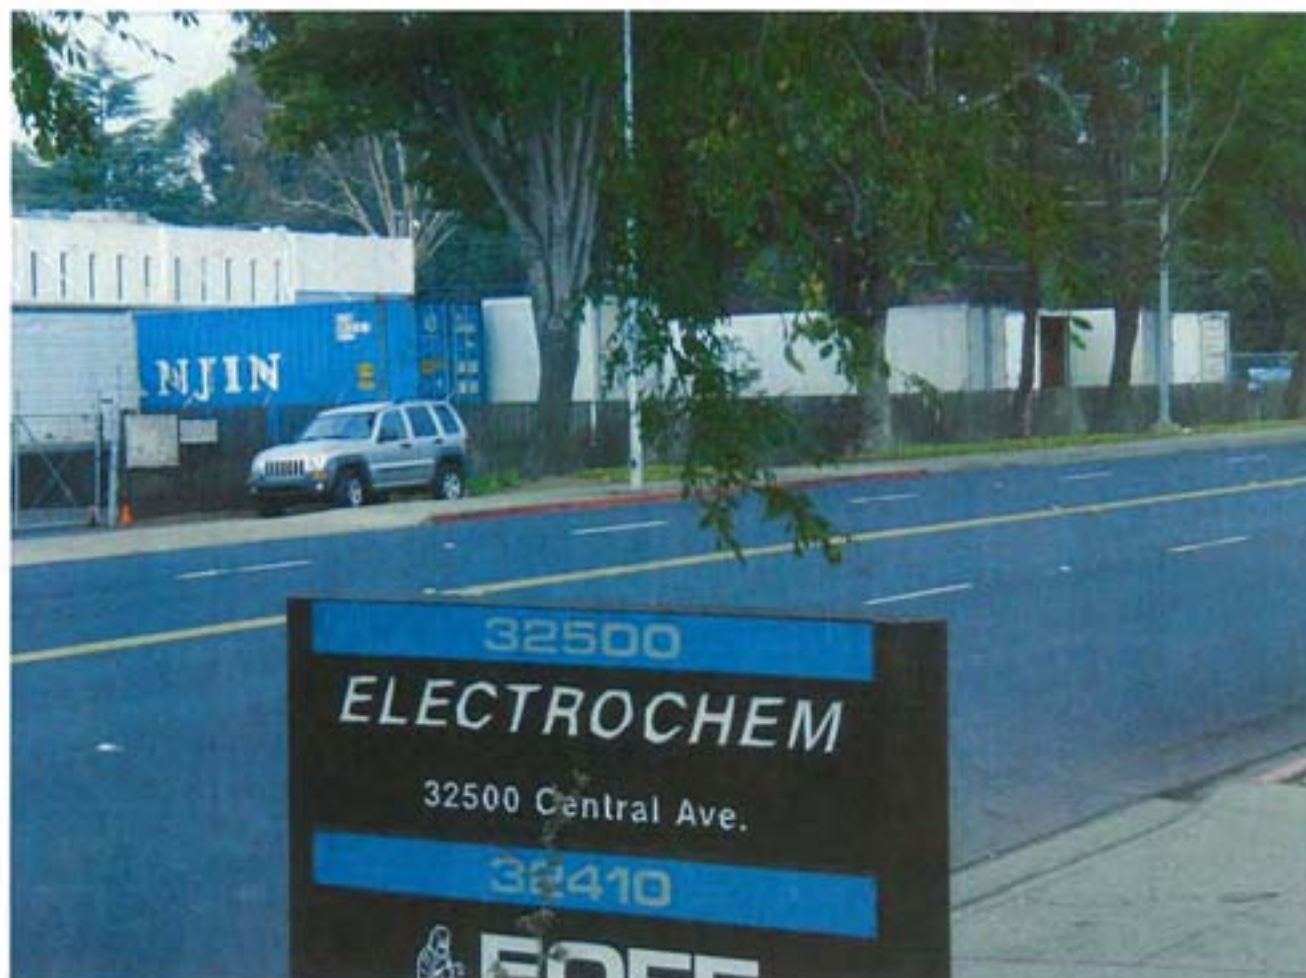
PC030001

- 001. Outdoor sign for Electrochem Solutions.
- 002. Production Room: All of the contents in the flammable cabinet are solvents used in the production process.

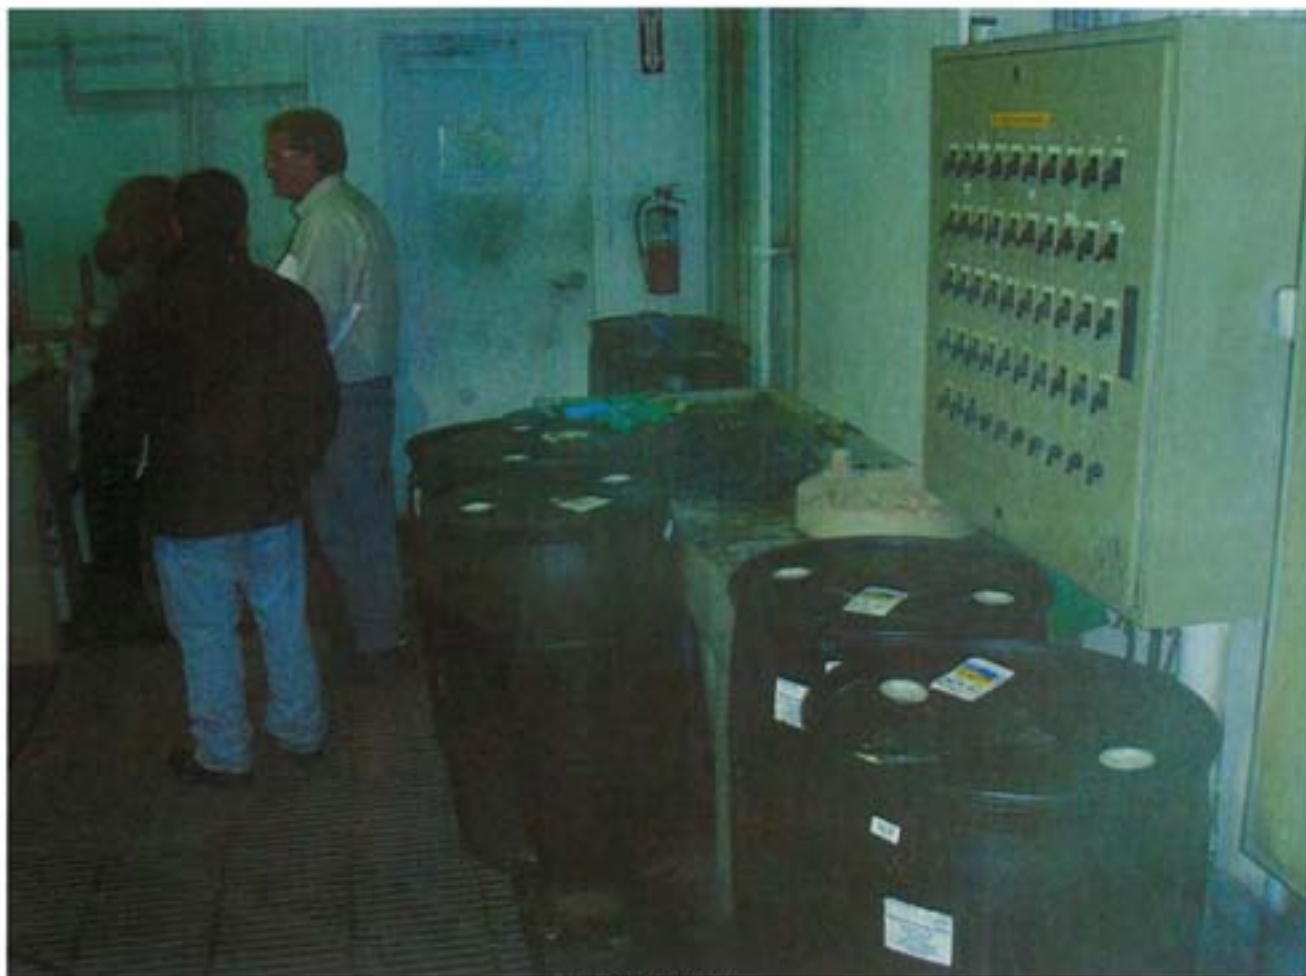
PC030005

- 005. Main Wet Processing Area: Six 55-gallon containers of gold strip (cyanide) including the two containers in the previous photograph. Four containers are labeled with the waste name and accumulation start dates.

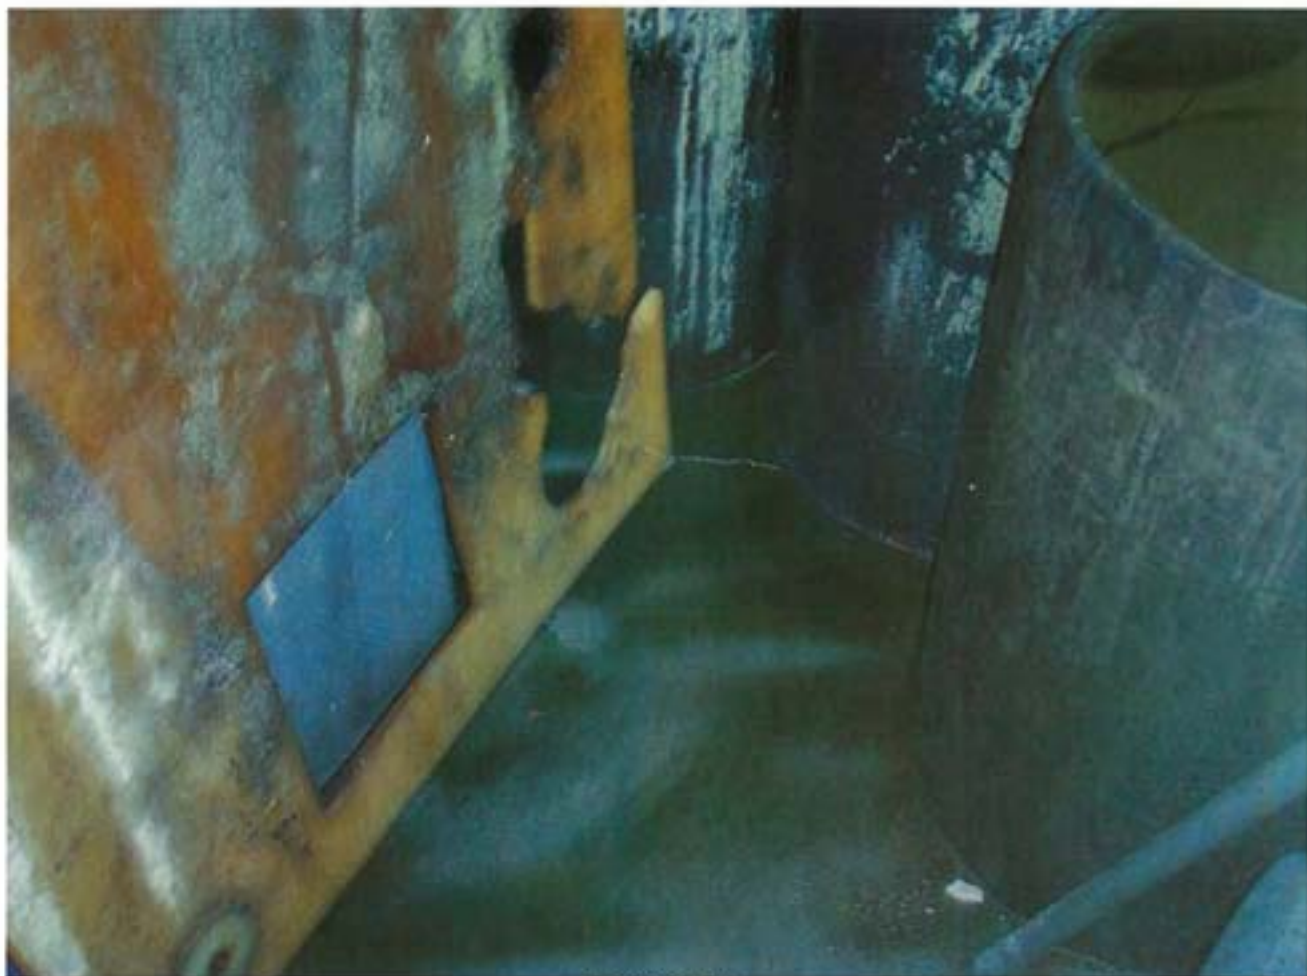
PC030042

- 041. Bulk Waste Processing Area: Approximately fourteen open top 55-gallon containers.
- 042. Bulk Waste Processing Area: Liquid observed on the floor in the area. The floor is lined, although torn in some locations.

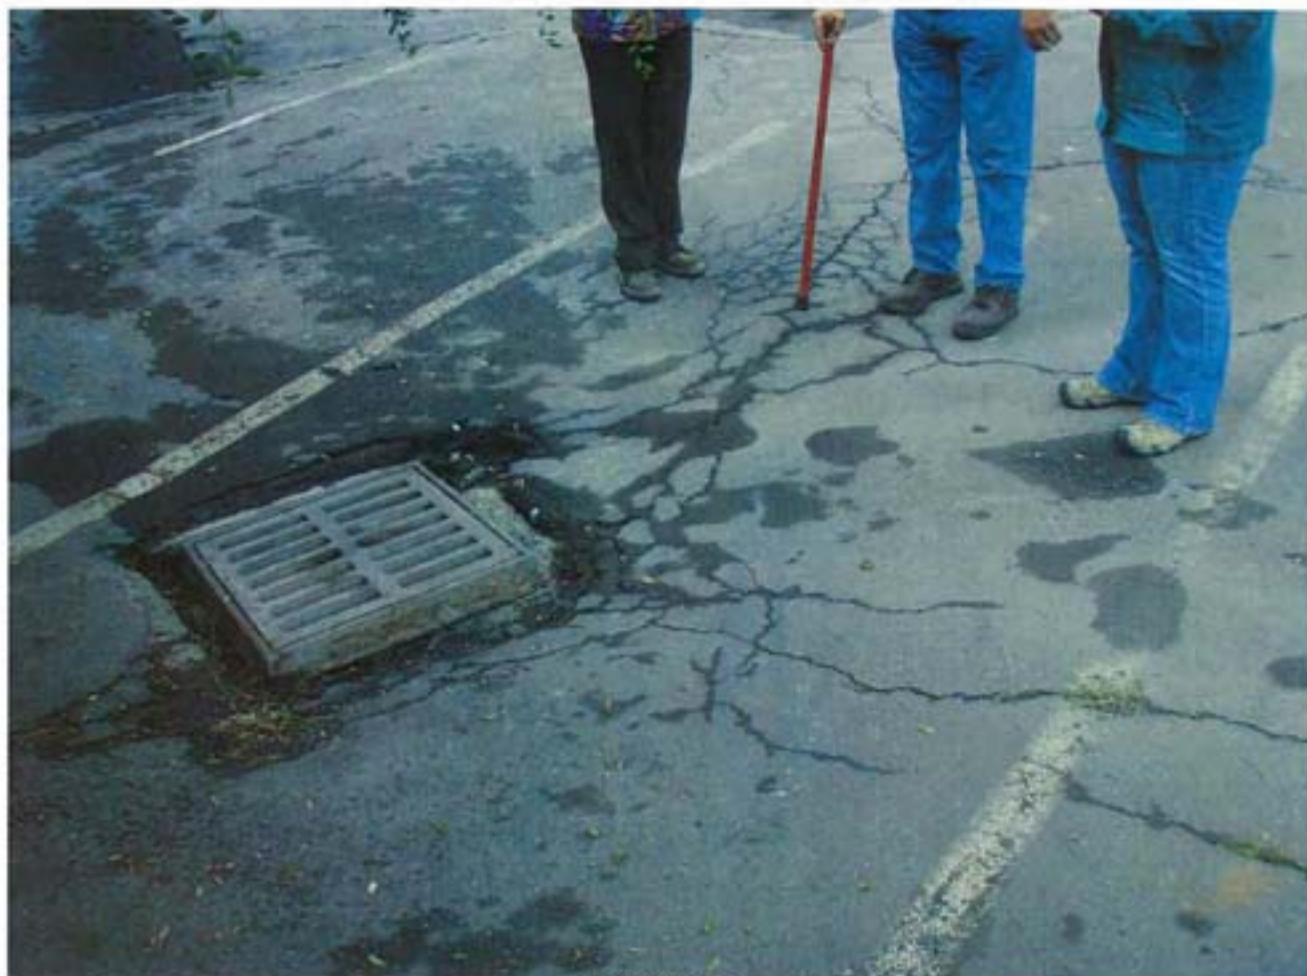
PC030058

- 058. Outdoor Area: storm drain approximately 30 feet from the back of the building.
- 059. Outdoor Area: View of storm drain in relationship to the building. Closest part of the building is the Less than 90-day Hazardous Waste Accumulation Area (Waste Chemical Storage).

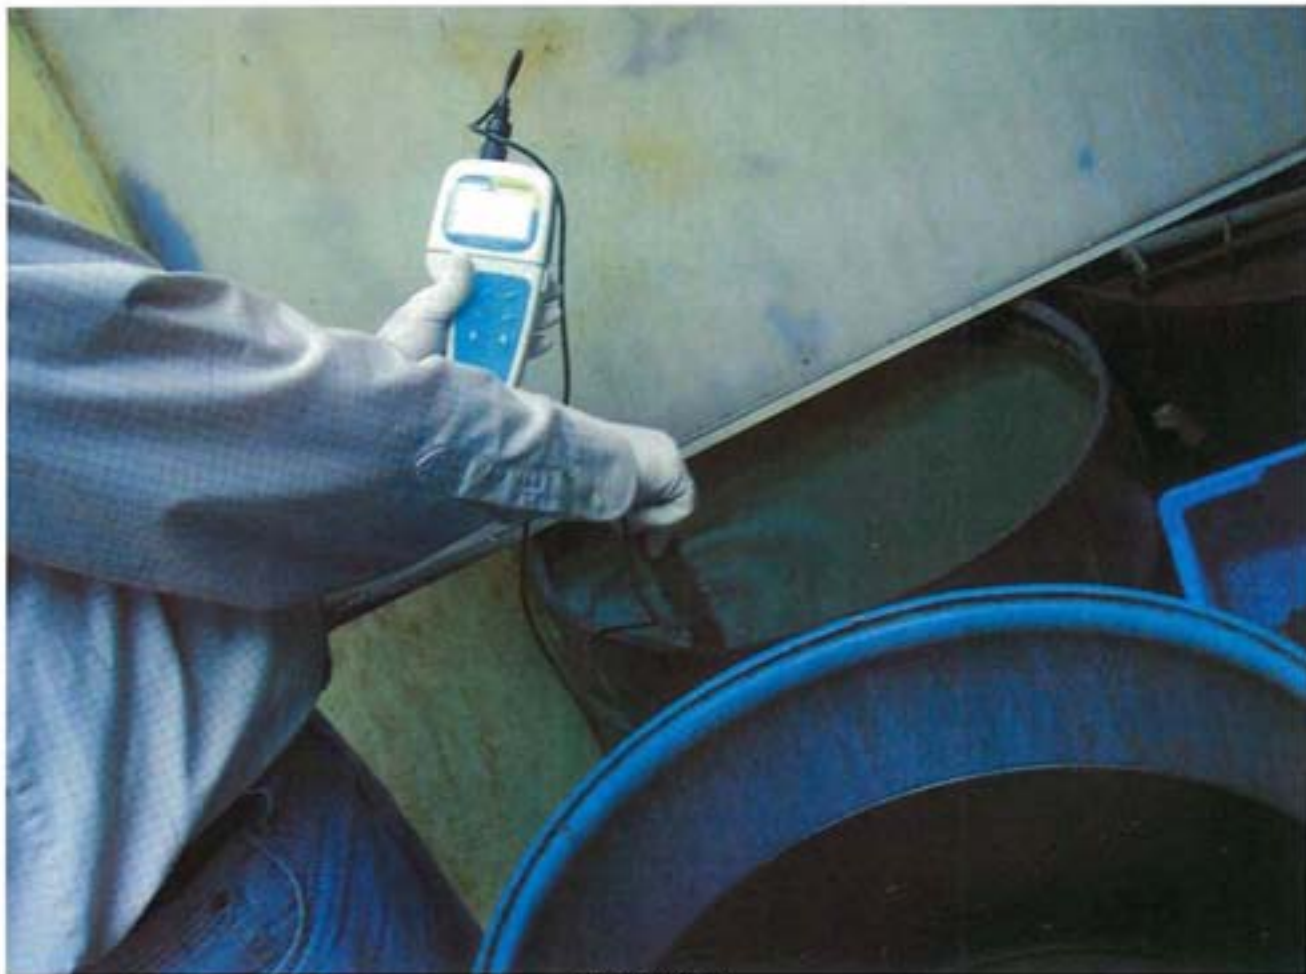
PC030126

126. John Schofield monitoring pH levels in hazardous waste treatment container located in the Bulk Waste Processing Area (*photograph taken by Chris Boykin*).
